SELF INSPECTION SHEET

SELF INSPECTION INDUSTRIAL QUALITY	Rev. 02	Project: PRASA	SI.FT1040.22
		DATE- 2022/06/22

FT1040

Car: 209 TC2

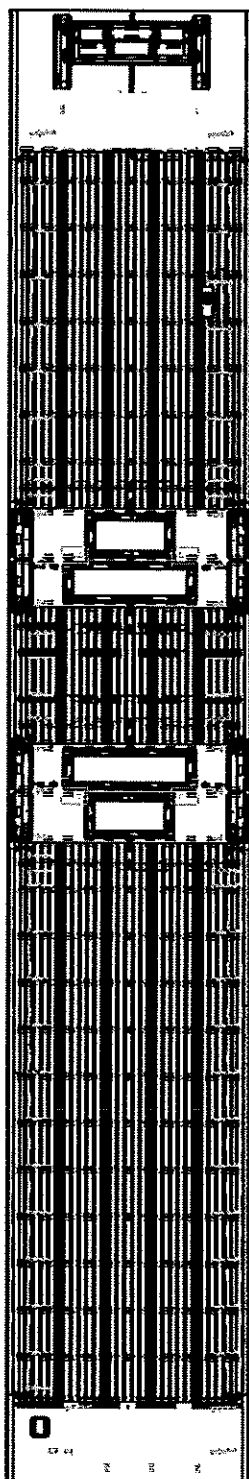
TC

END 1

END 2

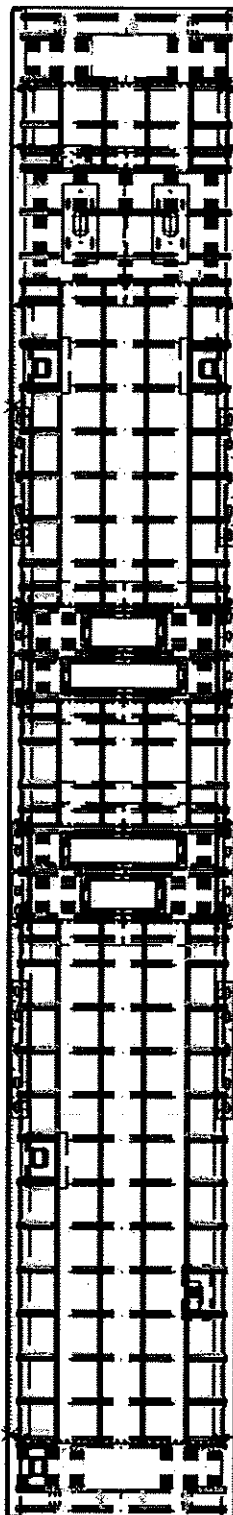
M1 and M2

END 1

END 2

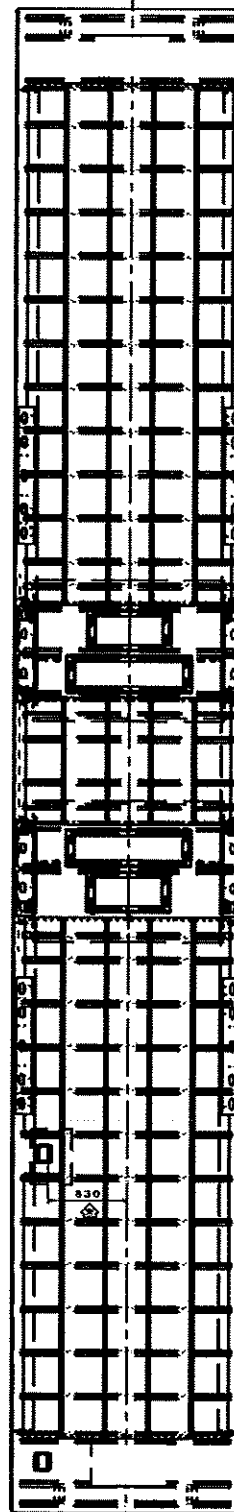
M3 and M4

END 1

END 2
